Request to Alter the 1874 Jacob Zimmerman House Historic Registry

Address: 17111 NE Sandy Blvd, Gresham, OR 97230

City of Gresham Urban Design and Planning
Historical & Cultural Landmark Alteration Narrative Statement

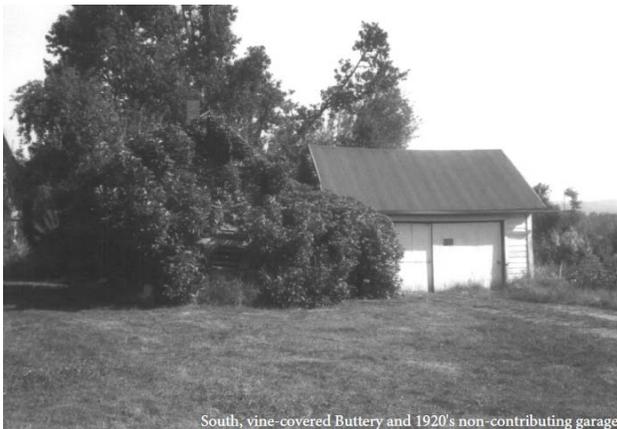
A photo taken by Juanita Graff in 1985 as part of the original application to have the Buttery listed on the National Register of Historic Places shows how overgrown the vegetation was on the Buttery building (see below). The narrative of the application states “Boston Ivy has overtaken the building and has damaged the brick veneer facing.”

South, vine-covered Buttery and 1920's non-contributing garage

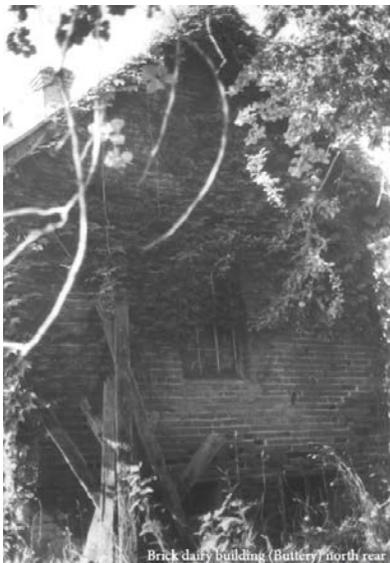
Brick dairy building (Buttery) north rear

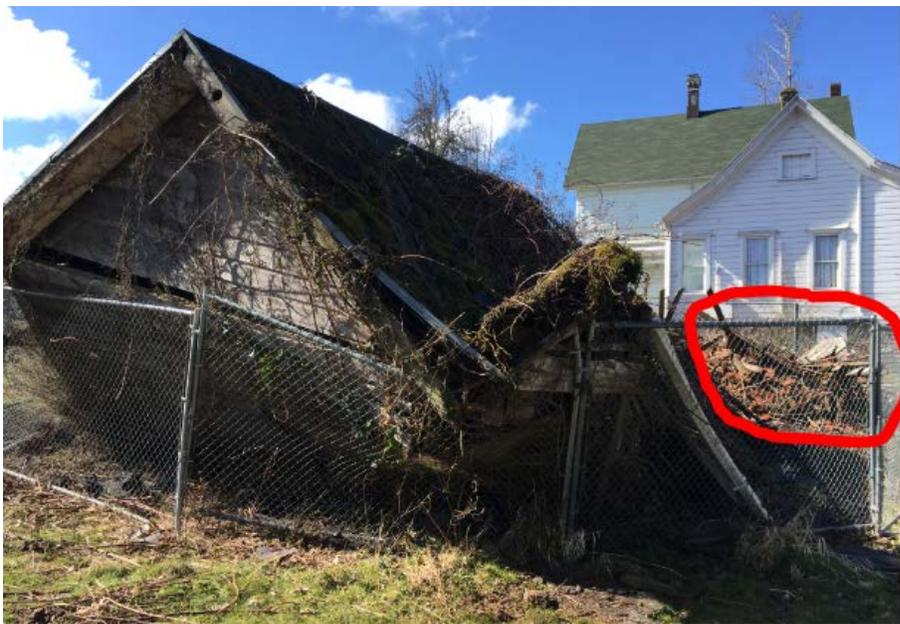
In April 2016, the Buttery collapsed and all that remained standing was the chimney. December 2016, a large Oak tree in the backyard fell and demolished the chimney and the Buttery remnants.

In March of this year, the garage next to the Buttery collapsed. ECHO took action getting permission and the permit to have the garage materials removed from the property. Circled below in what the area where the Buttery once stood look likes.

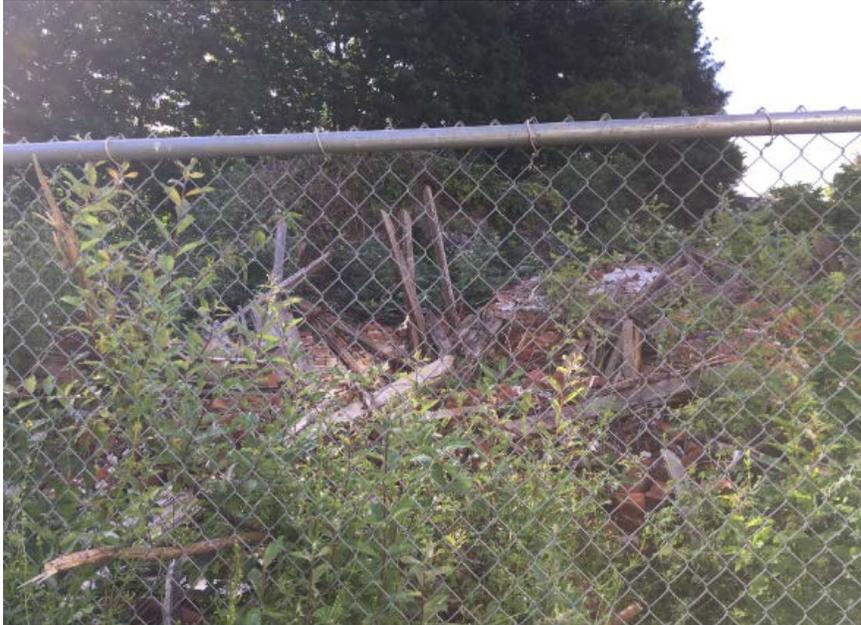
The City of Gresham Parks Division fenced the remains of the Buttery for safety purposes as well as to preserve the area until ECHO receives approval to alter the Buttery site.

Once permission is granted, ECHO has partnered with Archaeological Investigations Northwest, Inc. (AINW) who has offered to help clear the blackberries, ivy and debris from the remnants of the Buttery. They will take photographs of the collapsed brick walls and work with ECHO on ideas for stabilizing a portion of the ruins for interpreting the former structure. In the future, it may be possible to conduct some archaeological excavations for further interpretation of the Buttery.
