RE: City of Gresham File No. PZ20126000353, Veranda Subdivision(the  
“Application”); Applicant’s Response to your July 22, 2021 Email Containing  
Four Questions

The answers to your questions are based on evidence contained in the September 22, 2021 “Wetland Determination Report” (the “Report”) prepared by Mr. Jason Smith of Castle-Rose Environmental. The Report is attached as **Exhibit 1** to this letter. The proposed future street plan is attached as **Exhibit 2** to this letter.

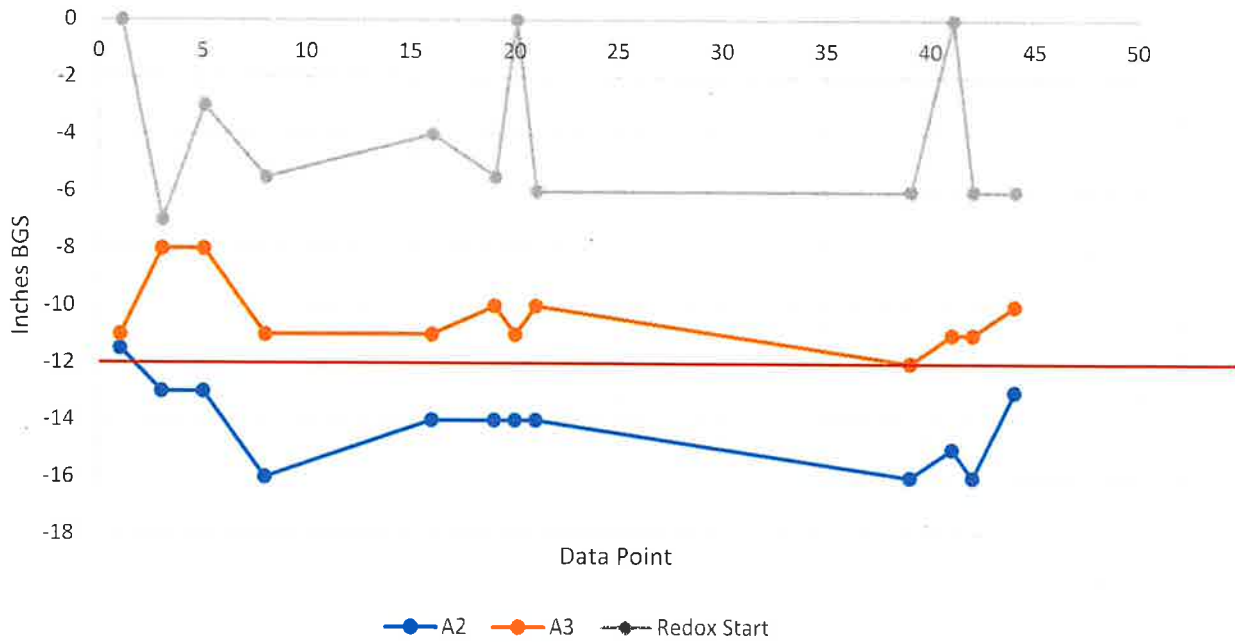
### April 2019 Report - A2/A3 vs. REDOX *within* Wetland 1

The observed A2 (Inundation) and A3 (Saturation) indicators do not correlate with the redoximorphic features. This is also true for the upland data points in documented in the April 2019 report and for the majority of the data points collected in 2020 and 2021.

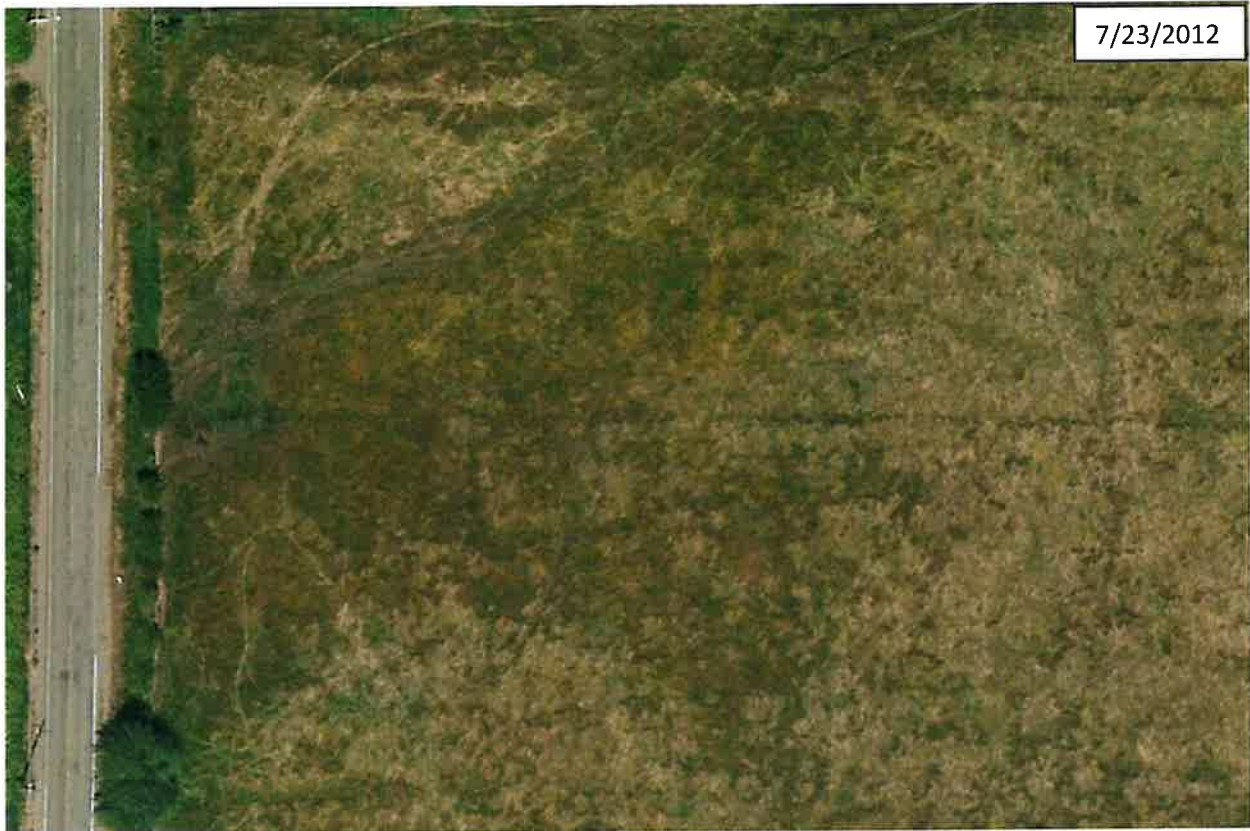
Google Earth Pro image dated 07/23/2012. Darker pattern is mix of hydrology and vegetation, as shown in imagery below dated less than one month later after haying. Technically, the image is not qualifying due to excessive precipitation 3-months prior (>40% difference from average). However, the 2012 imagery has two data points – similar to 2018 which has a -12% difference in 3-month prior precipitation and is qualifying. The wetness conditions patterns are very similar, reinforcing the wetland boundary.

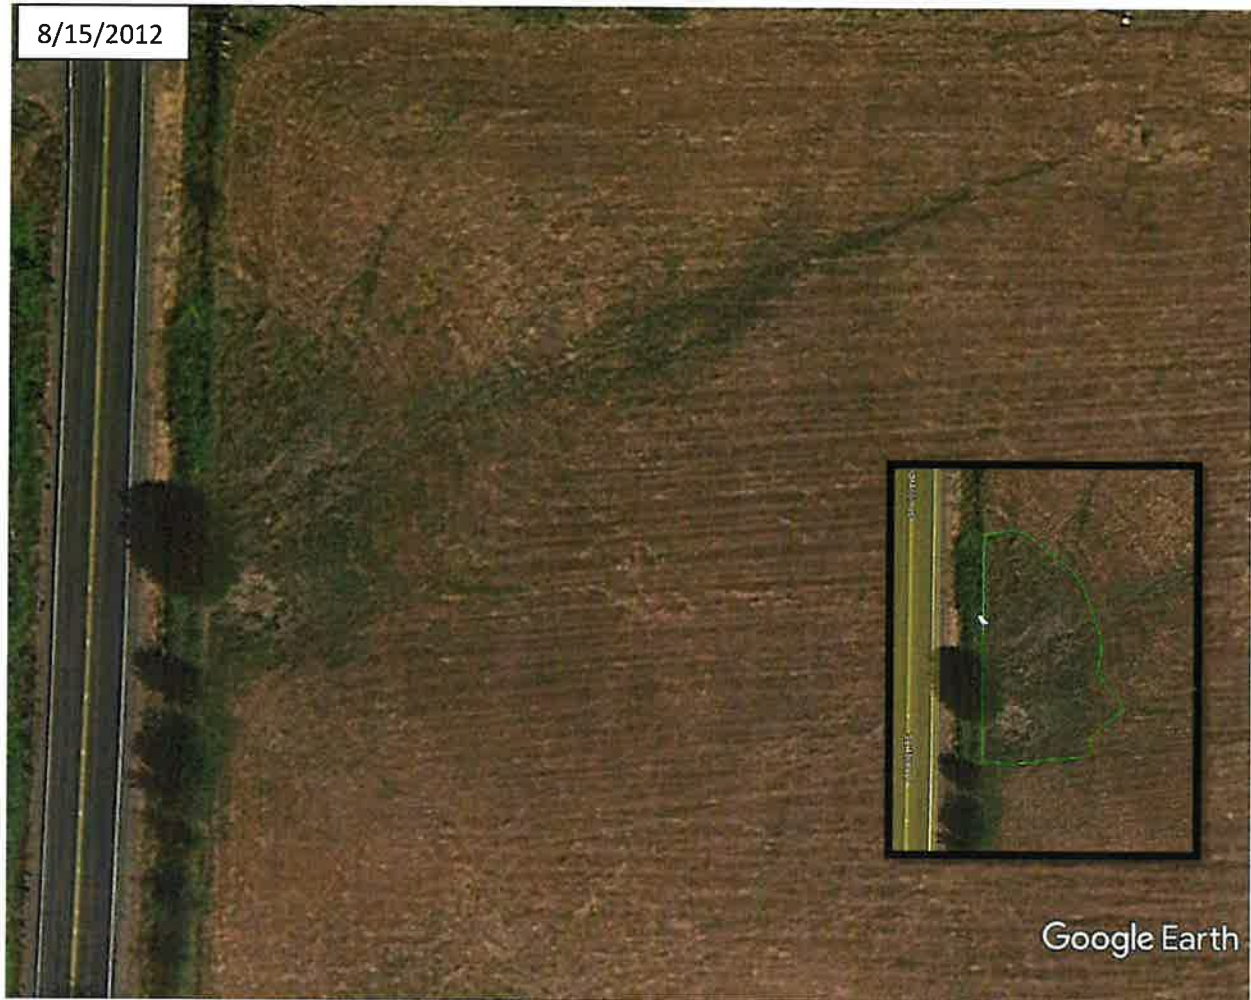
The wetness pattern is definitive in the August 8, 2012 imagery. The closeups on the left show the wetness profile in relationship to the sampling points from 2020. No sampling performed in this area prior to 2020. The wetland area matches several wetness conditions, such as unharvested crop (no haying in the wetland); greener color in the dry season; different vegetation pattern. As noted for the July 2012 imagery, precipitation was 40.2% higher than average in the three months preceding the image date. The narrow green “spike” to the west of the wetland is not included in the boundary based on lack of hydrophytic plant community (and lack of observed hydrology in July 2020 compared to the wetland hydrology). The green spike does not appear consistently within the historical aerial imagery.

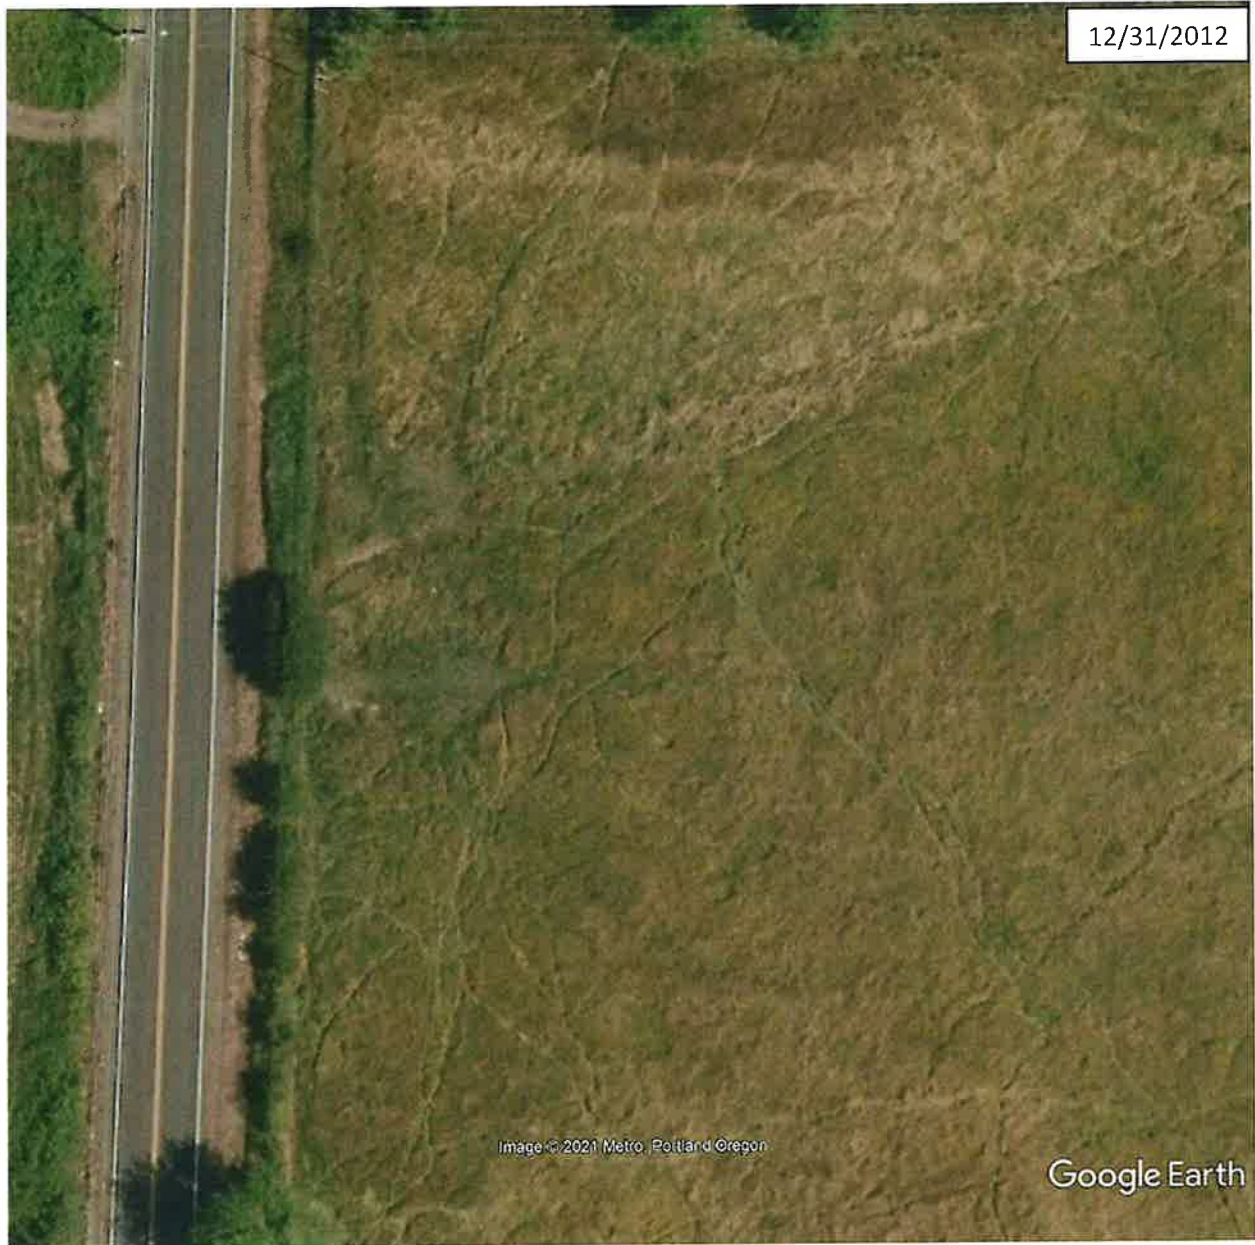
Although not a qualifying image under the Difficult Wetlands Situations protocol (non-growing season imagery) the wetland area remains consistent into the wet, non-growing season. Lines are livestock grazing patterns etched into the soil.

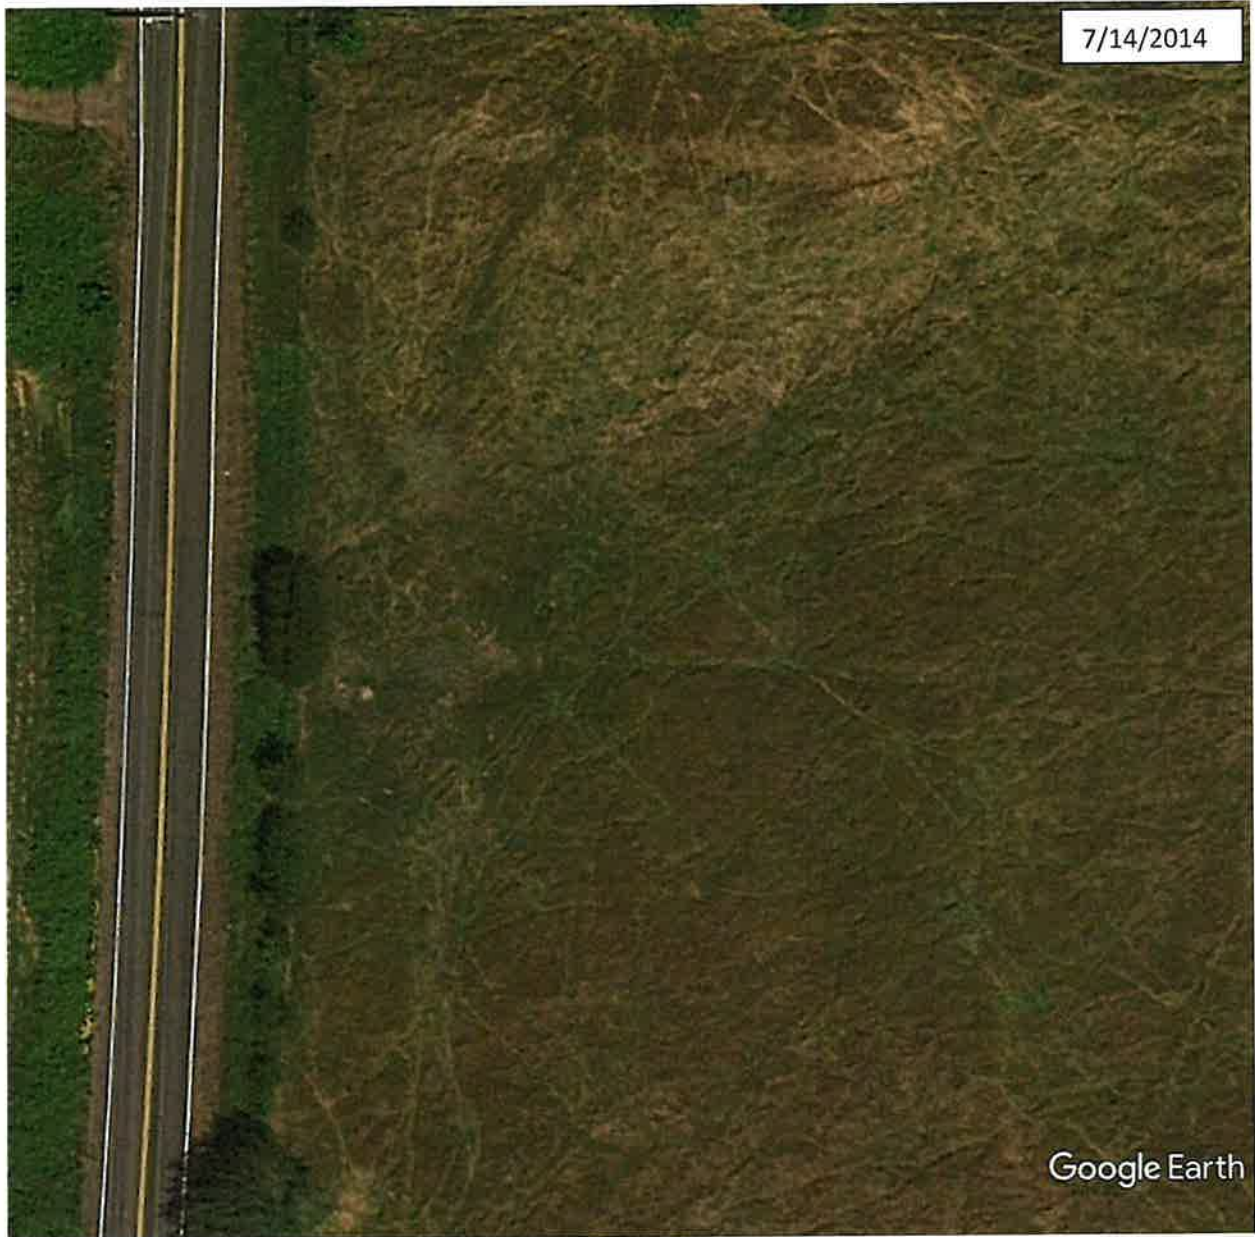
In July, 2014 – differences in vegetation pattern slightly distinguishable as a wetness condition. 3-month prior precipitation -2%. Lines are grazing patterns and are persistent into recent years.

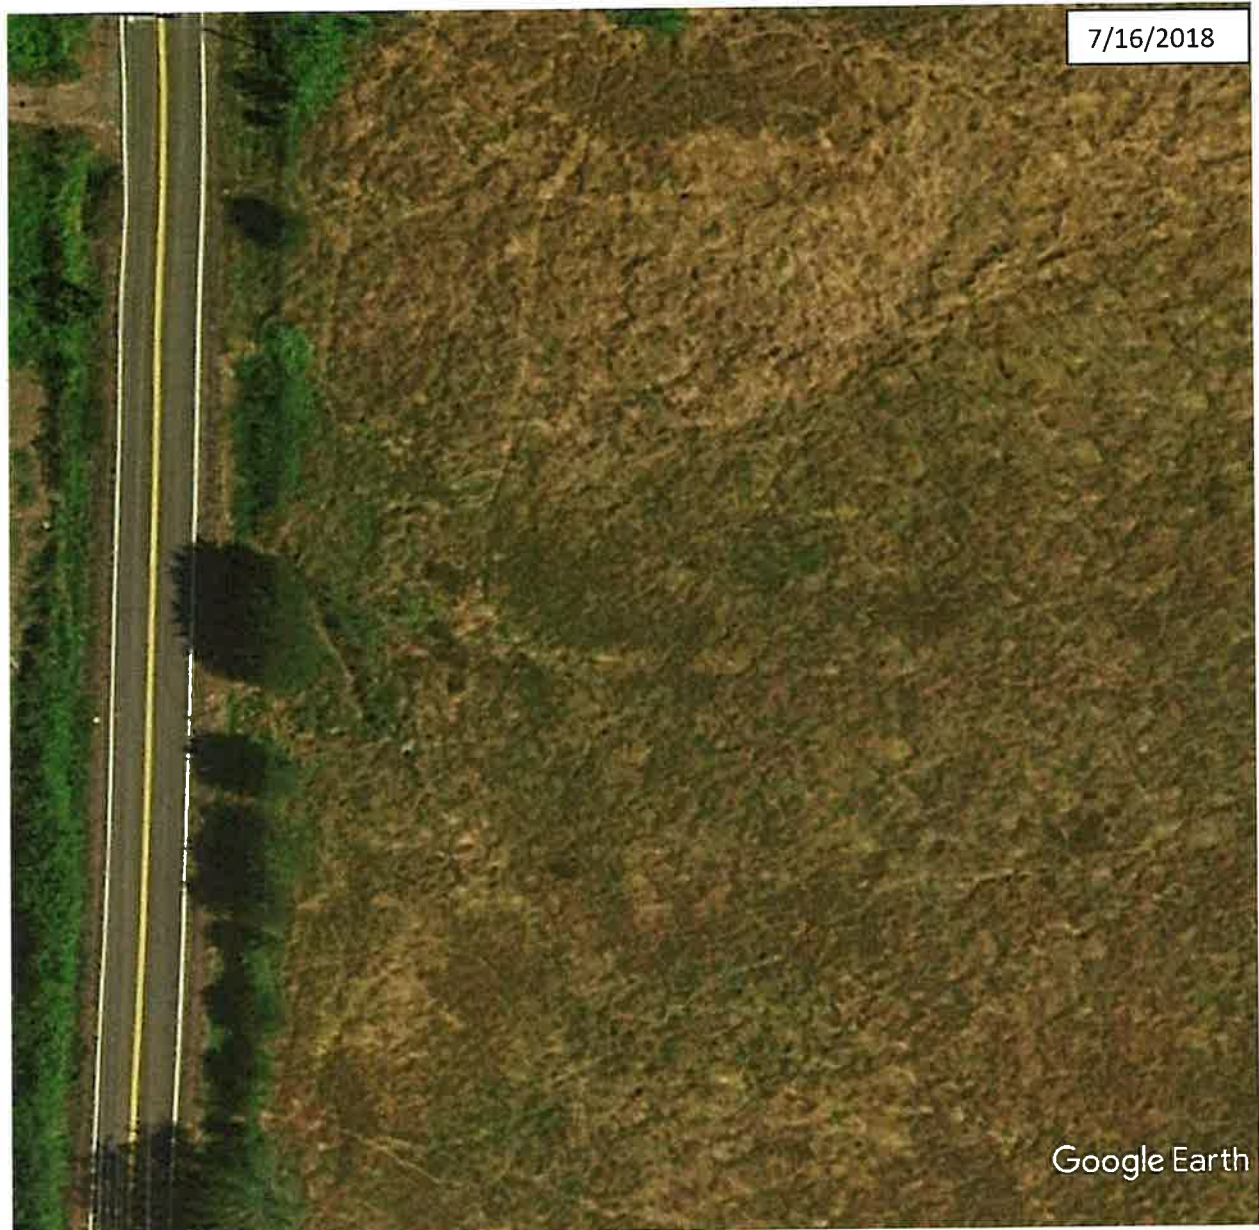
July 16, 2018 image collected four days before haying. Wetness conditions distinguishable between uplands and wetland (color; vegetation pattern). The current ditch draining the wetland is now visible vs. the 2017 image.

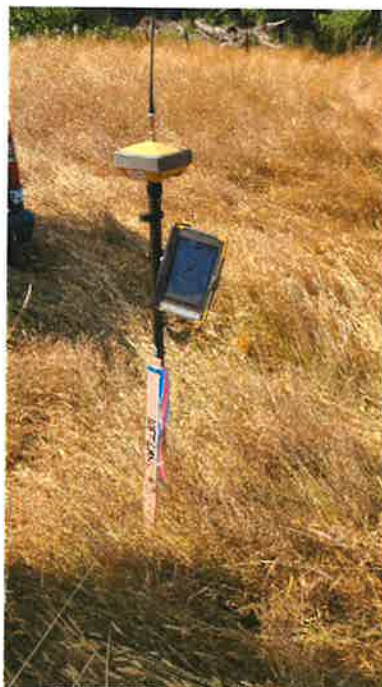
Data points and the wetland boundary were mapped using sub-meter Trimble GNSS technology by All County Surveyors:

The wetland boundary was identified using two methods: 1) vegetation as the surface indicator; 2) historical aerial photography. The two methods identified a surface area of approximately 5,250 s.f. and 5,227 s.f., respectively.
